## Area of Concern – Site: P07

Map Grid Location: D10 Site visit date/ team): 4/13/15/ BK, JZ Drainage Area (Sq. Mi.): 0.89  
 Name & Location: Culvert under Corn Mill Shoals Trail

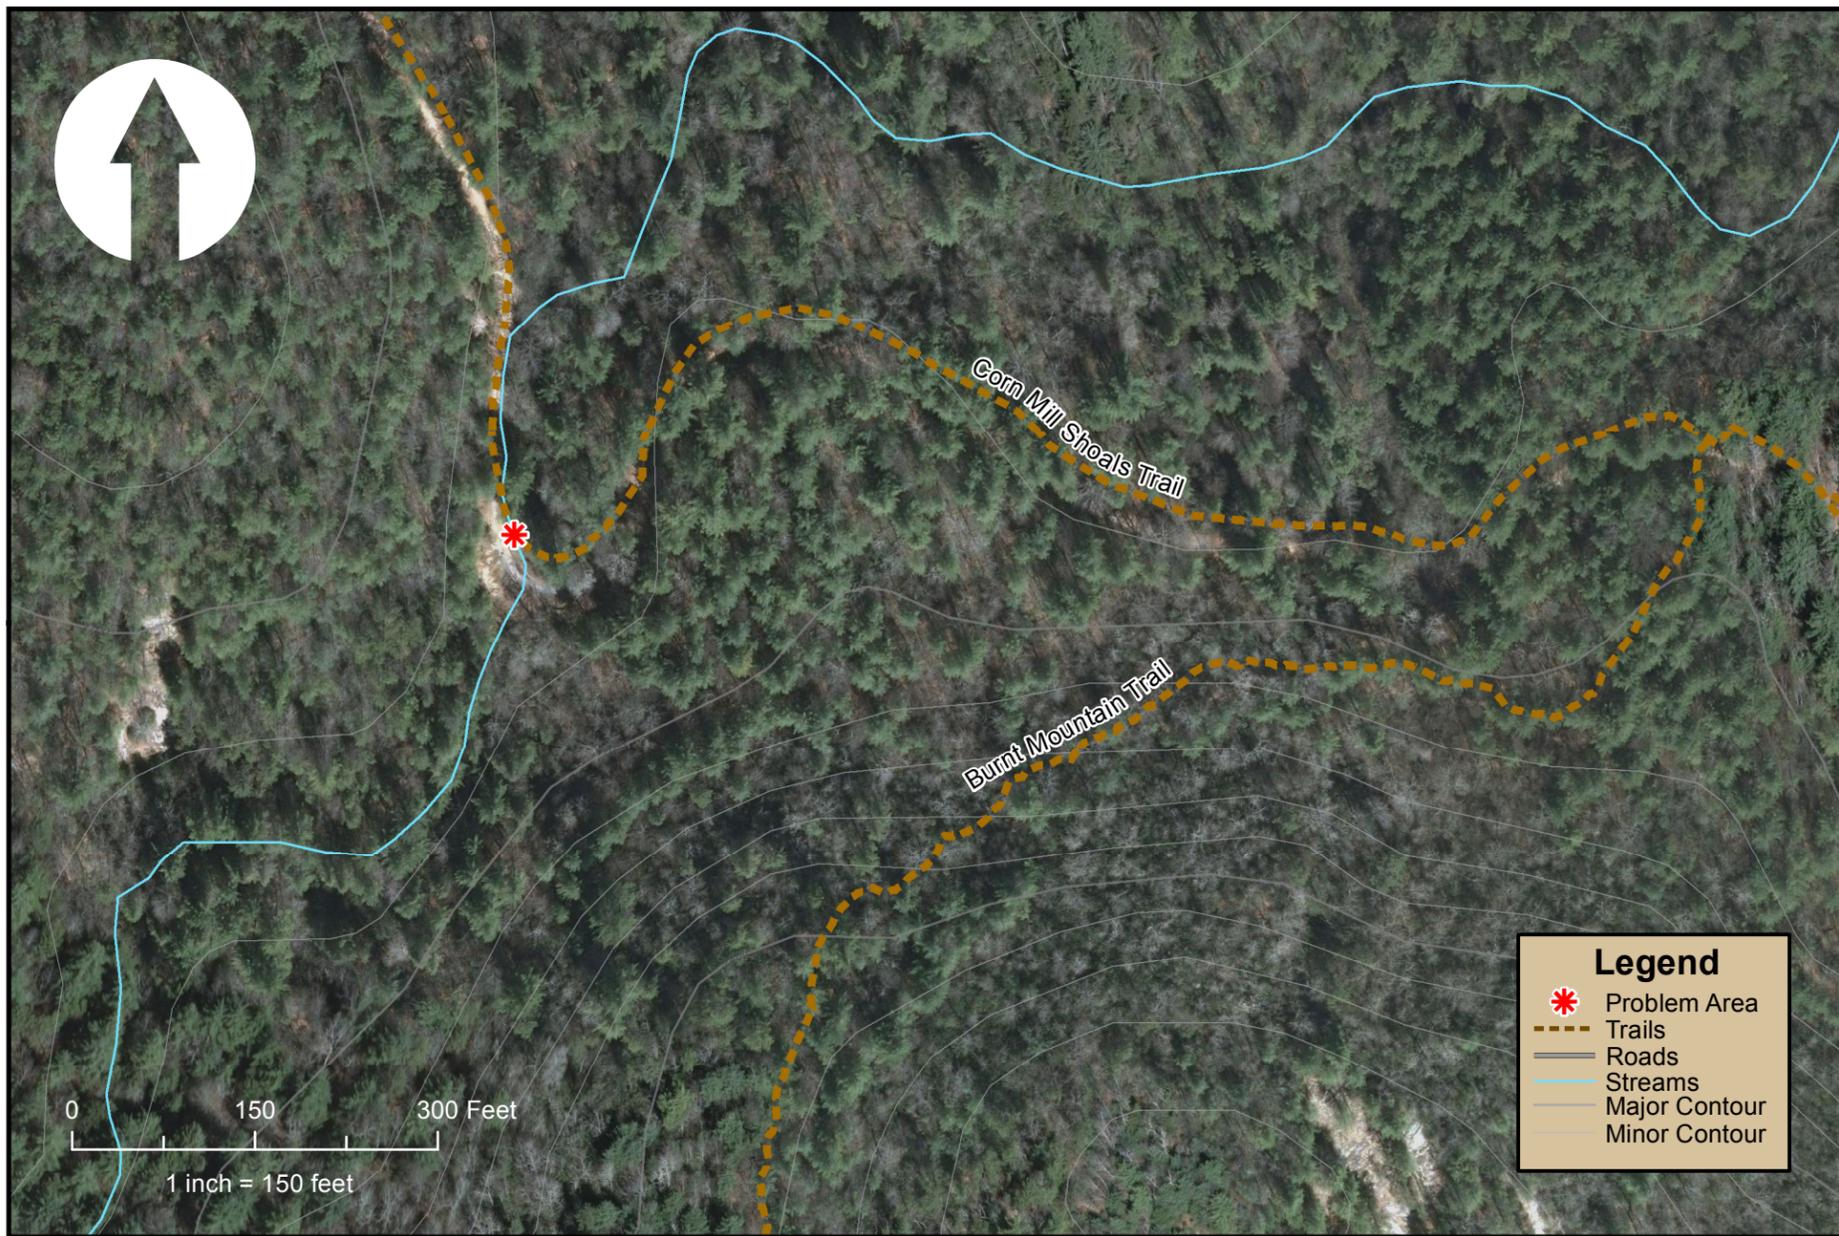
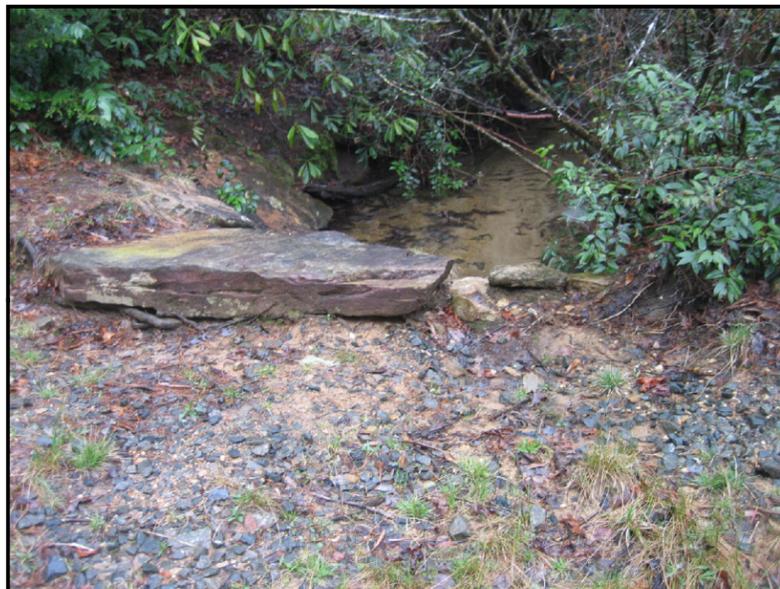
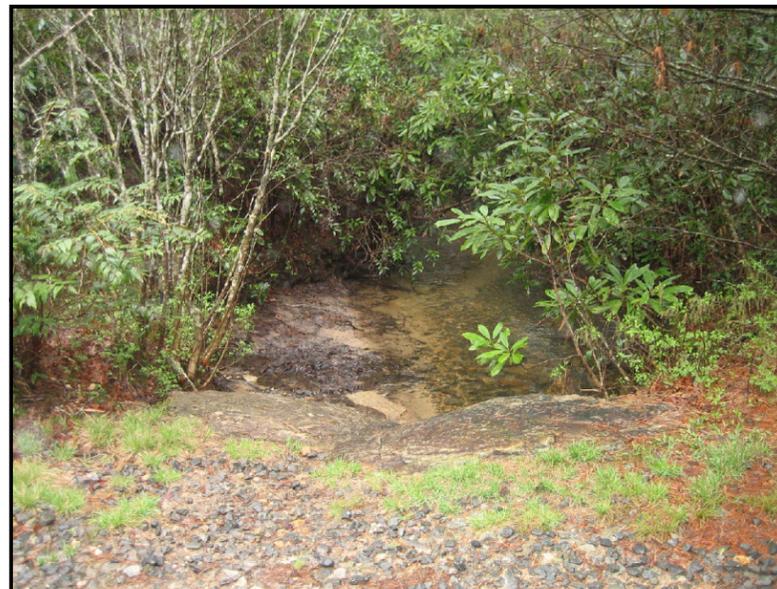
- 2. Trail/ Road Impact (trail/ road name):** Corn Mill Shoals Trail
- |  |  |

| <input checked="" type="checkbox"/> stormwater input | <input checked="" type="checkbox"/> sediment input |
| <input type="checkbox"/> safety hazard | <input checked="" type="checkbox"/> human impact (hiking/biking) |
| <input checked="" type="checkbox"/> missing vegetation | <input type="checkbox"/> equine/dog impacts |

Minor sediment/ stormwater input to stream at trail crossing – install vegetation and/ or regrade trail for improvement.

| <input type="checkbox"/> relocate trail/close trail/road | <input checked="" type="checkbox"/> trail/road crossing improvement |
| <input checked="" type="checkbox"/> vegetation/ shoreline planting | <input type="checkbox"/> mechanical grading |
