Area of Concern – Site: P26

Map Grid Location: J8 Site visit date/ team): 8/30/15/ JZ Drainage Area (Sq. Mi.): < 0.1
 Name & Location: Tributary to Briery Fork Creek at Joanna Road

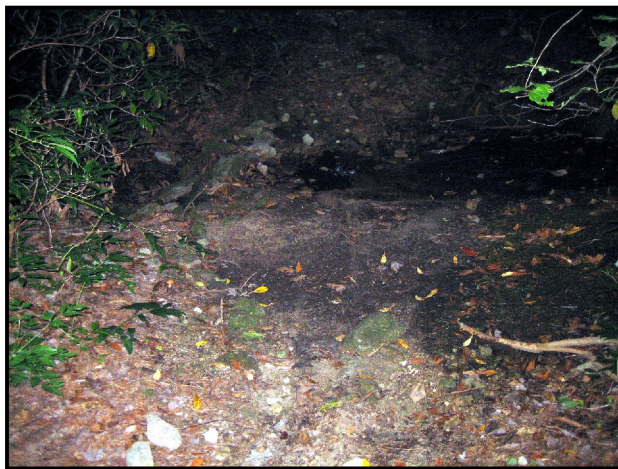
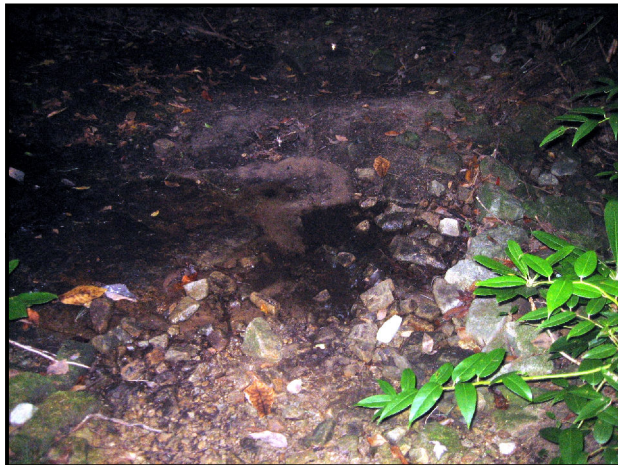
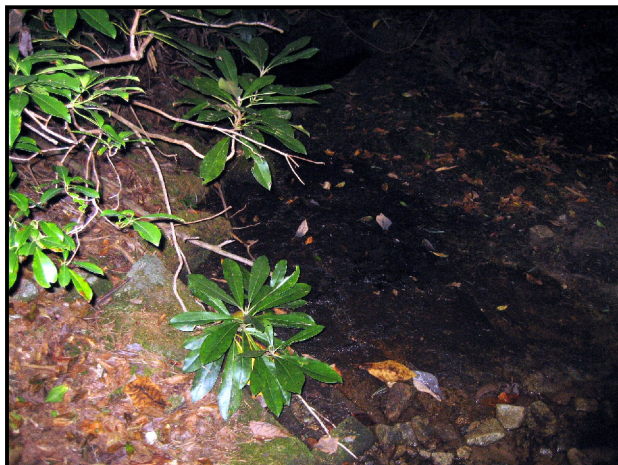
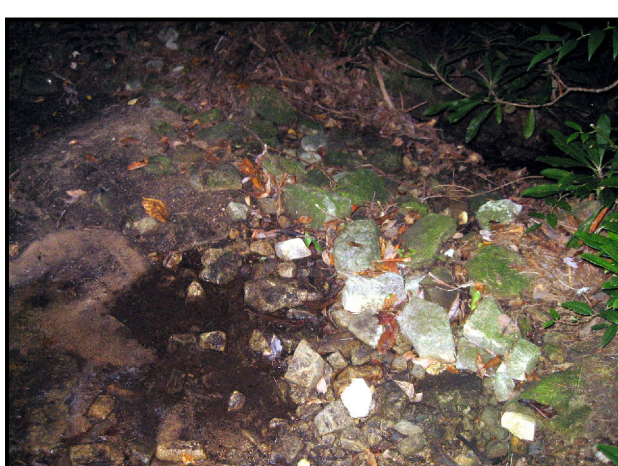
2. **Trail/ Road Impact (trail/ road name):** Joanna Road

<input checked="" type="checkbox"/> stormwater input	<input checked="" type="checkbox"/> sediment input
<input type="checkbox"/> bridge	<input type="checkbox"/> utilities
<input checked="" type="checkbox"/> unstable trail crossing	<input type="checkbox"/> erosion
<input type="checkbox"/> safety hazard	<input checked="" type="checkbox"/> human impact (hiking/biking)
<input type="checkbox"/> missing vegetation	<input type="checkbox"/> equine/dog impacts

Comments
 Trail crossing serves as source of fine sediment. Potentially install bridge/ culvert or sediment traps/ diversions on trail.

| <input checked="" type="checkbox"/> relocate trail/close trail/road | <input checked="" type="checkbox"/> trail/road crossing improvement |
